Compliance Evaluation Inspection Report

Date of Inspection: February 28, 2017

Facility Name: Mid-America Steel Drum

Facility Address: 3950 South Pennsylvania Avenue
St. Francis, Wisconsin 53235

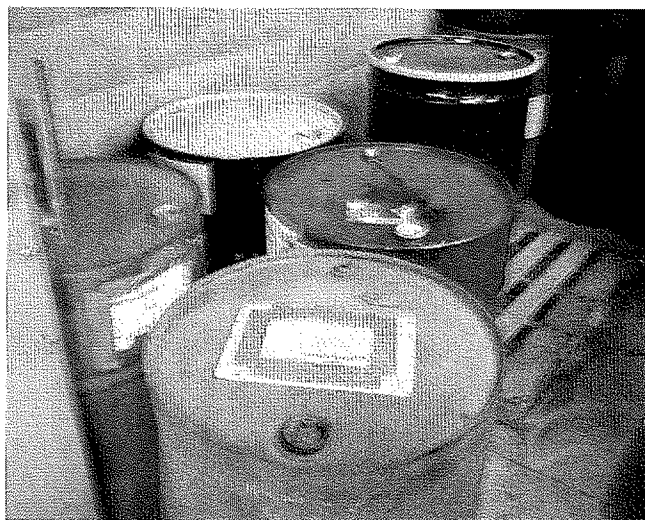
Photograph 3

Five 55-gallon drums in various conditions were set aside on the truck dock as "Heavies." These containers were not marked with individual labels indicating that they were to be returned to the vendor. However, they were in an area that was demarked for Heavies.

Heavies are segregated off to the side of the dock. Five heavy drums were in storage at the time of the inspection. The drums maintained their original labels and had not been opened or modified by MASD-SF. The drums were not marked with dates of receipt. Tractor trailers at the dock were opened so that we could see their contents. One of the trailers held bags of metasilicate pentahydrate which is a drum conditioner formerly used at the site for rust-preventions. Mr. Furgason stated that this material was still product. Another trailer of "non-cleanable" plastic drums was to be shredded. Mr. Furgason did not elaborate on the definition of "non-cleanable."

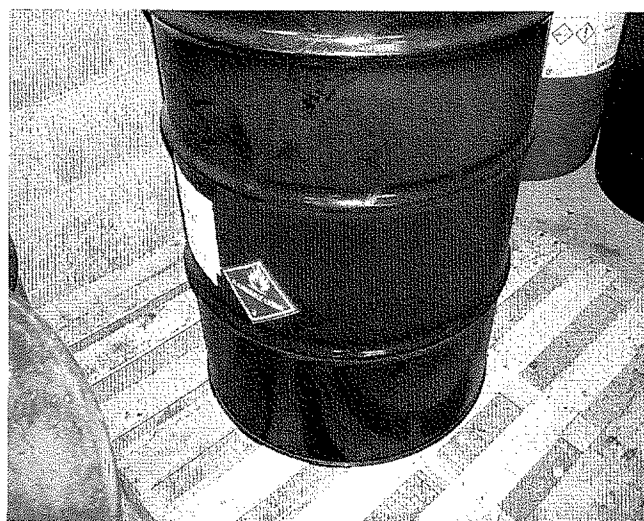
Photograph 4

One of the Heavy containers had a "Flammable Liquid" label. This particular container had a seal around the bung clasp indicating that it was a product that had never been used.

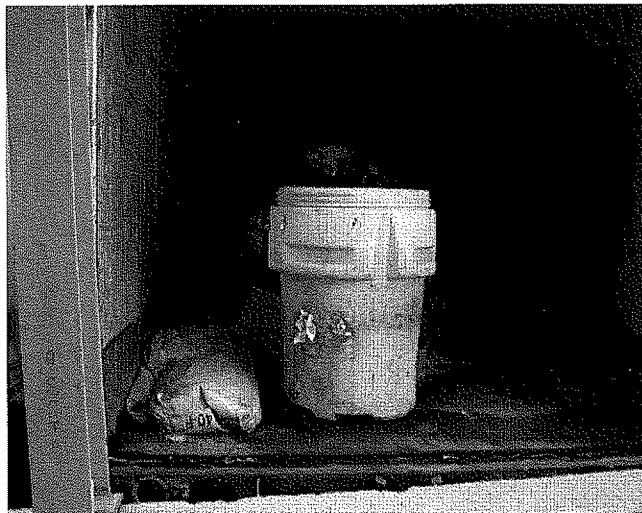
Photograph 5

A trailer backed up to the dock contained a pallet of Metasilicate Pentahydrate. According to Mr. Furgason, this material is used as a rust inhibiting drum conditioner.

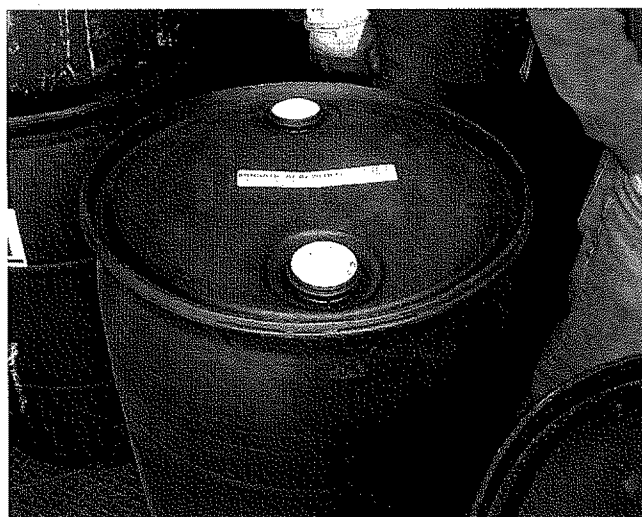
Photograph 6

This 55-gallon drum was staged on the truck dock. Visible fumes were emanating from the bung cap. The drum had contained acid. According to Mr. Furgason, the bung cap had not been fastened tightly, and most likely some acid on the cap was reacting to moisture in the air.

The tour began at the truck dock. I observed the operators as they made their determinations by feel of whether the drums were RCRA-empty. Plastic drums are stacked two high awaiting processing. Two drums were fuming at the time of the inspections. The drums were pulled from the stacks. It was determined that the bung rings were not tightly fastened and the residual acid in the drum was reacting to moisture in the air. The steel drums are rolled over to the conveyors to be transferred inside the building for washing. The plastic drums are reloaded into trucks to be moved to another side of the building for their own wash system.

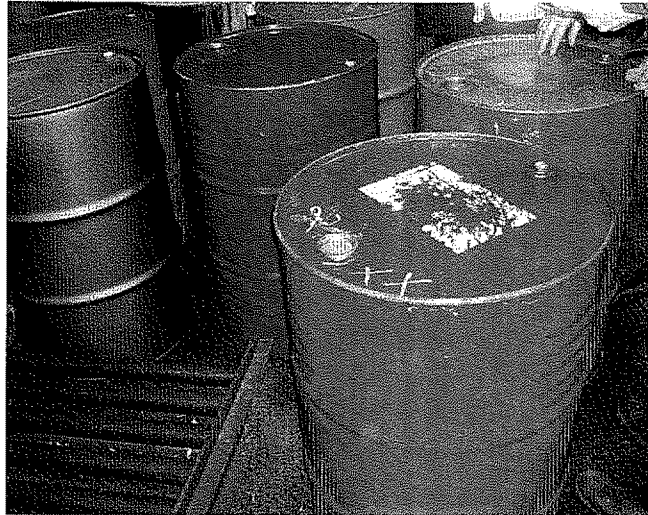
Photograph 7

Each of the drums in this photograph had been processed through an acid wash and hot water rinse to remove rust. The two red 55-gallon drums in the forefront of this photograph were fuming. The white fumes can be seen in the bung hole of the foremost drum. These containers smelled strongly of organics though they were empty.

The drums proceeded to rust inspection. The rusty drums are processed through the muriatic acid wash. The acid is rinsed out of the drums with water from the first hot water tank. I observed some drums that had been removed from the acid wash operation that were fuming out of the open bung rings. These containers were contaminated with VOCs as indicated by odors and by readings on the Multi-RAE. Also, acid in contact with moisture, as with the drums observed on the dock, will fume. The drums were otherwise empty.
